**CONSOLIDATED SEWER MAINTENANCE DISTRICT
CONDITION ASSESSMENT PROGRAM REPORT
PROJECT NO. Y0TV0910C**

**CONDITION ASSESSMENT REPORT
COUNTY OF LOS ANGELES DEPARTMENT OF PUBLIC WORKS
CONSOLIDATED SEWER MAINTENANCE DISTRICT**

PROJECT NAME:	Y0TV0910C	PROJECT MGR:	Hanna Kebede
PROJECT DATE:	01/27/2011	CONTACT NO:	(626) 300-4686
SUP. DISTRICT(s):	5	MAP PAGE(S):	1851 & 1852
Report By:	Hanna Kebede	Report Date:	02/09/2013

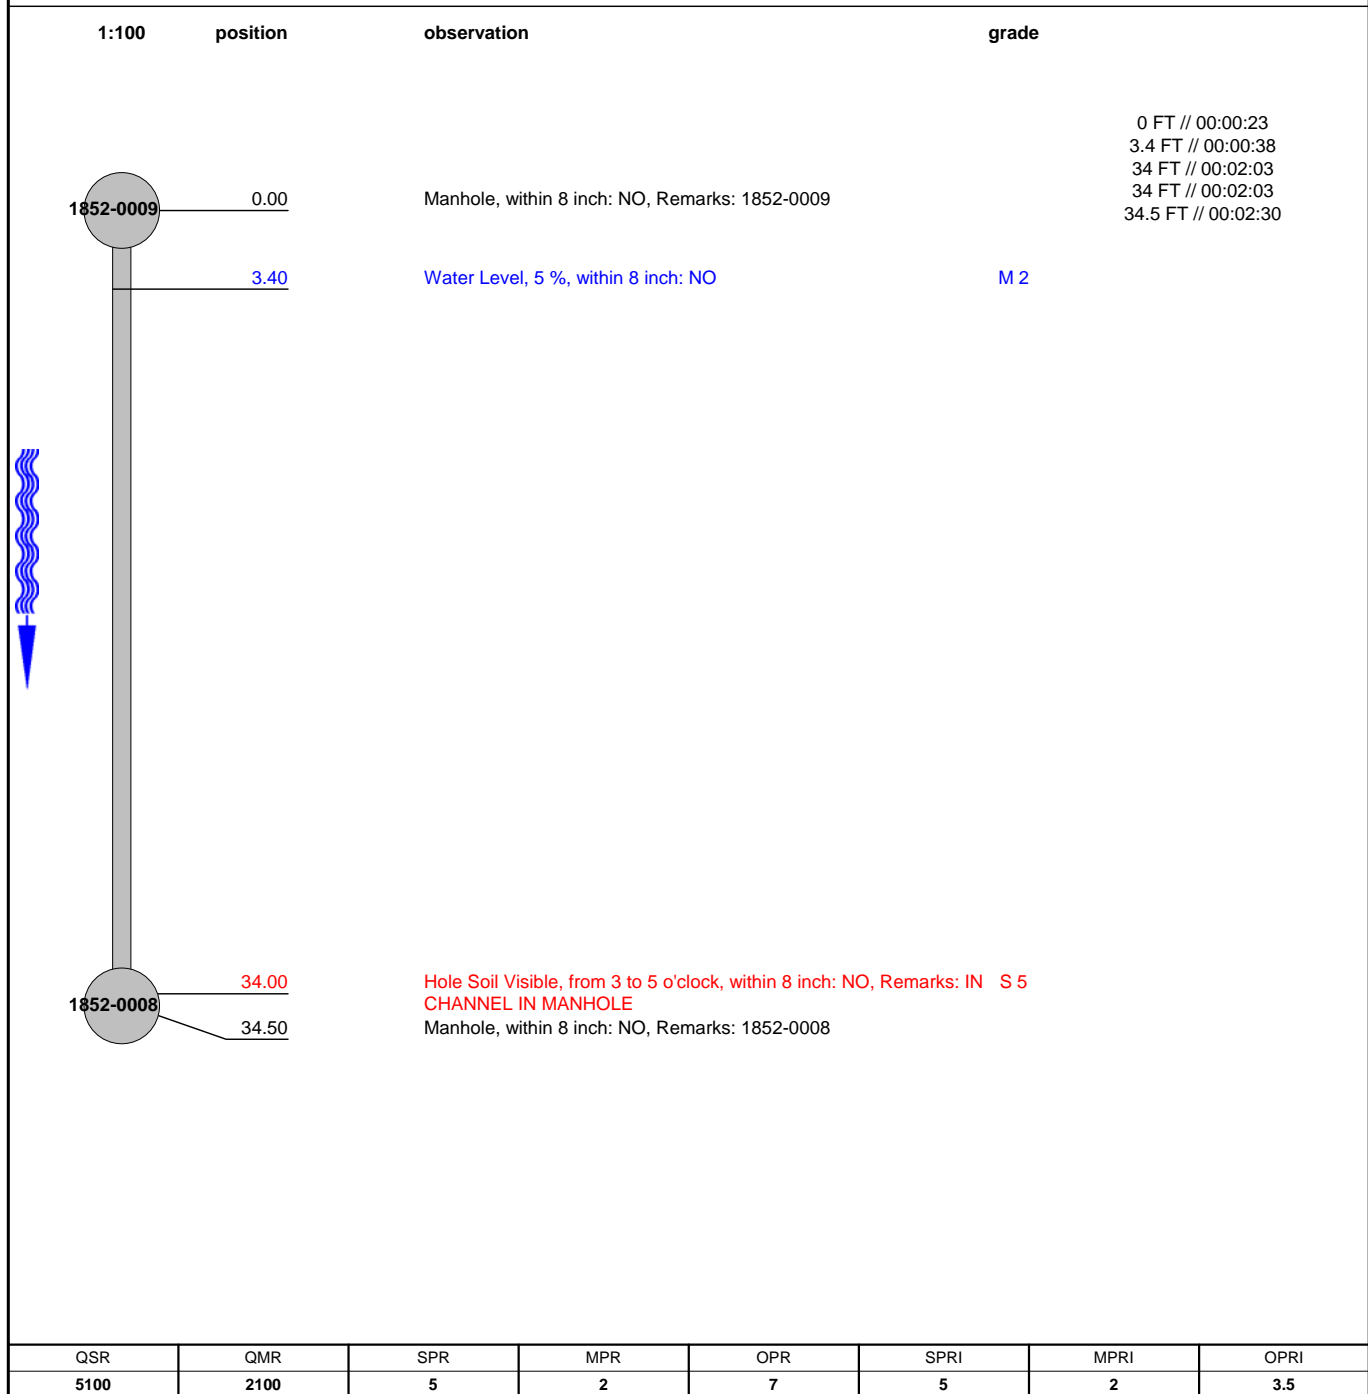
Street:	STARDUST RD	Flow Control:	Not Controlled	Start MH:	1852-0009
City:	LCF	Year Renewed		End MH:	1852-0008
Location Code:	Light Highway	Tape/Media #:	M315-068	pipe length:	34.5 ft
Reason for inspection:	Routine Assessment		Dia/Height:	Circular 8"	
Use of Sewer:	Sanitary		Material:	Vitrified Clay Pipe Pipe Length:	
Drain. Area:	0009/1852-0008/1852		Lining Method:		
Remark::

ITEM NO.	QSR	START MH	END MH	STREET	OBSERVATION: LOCATION	PROPOSED CORRECTIVE ACTION	LENGTH (FT)
1	513B	1851-0033	1851-0034	EASEMENT	Broken with visible void: base of MH 34	CSMD will repair base of MH 34.	
2	513A	1852-0134	1852-0164	SAN JUAN WY	Broken/fractures: 2'	Structural integrity intact. No action needed.	
3	5142	1851-0078	1851-0079	EASEMENT	Broken : 99' - 101'	Point Repair	
4	5141	1851-0117	1851-0118	BURNING TREE DR	Fractures: 167', 180'; hole at base of MH 118	CSMD will repair base of MH 118.	
5	5141	1851-0147	1851-0146	MEADOWVIEW DR	Fractures/cracks; multiple locations; broken base at MH 146	Lining: MH to MH ; CSMD will repair base of MH 146	263
6	5121	1851-0100	1851-0101	GODBEY DR	Broken: 25'; fractures	Lining: MH to MH	150
7	5121	1852-0012	1852-0011	MARINERS VIEW LN	Broken (tap break-in): 113'; fractures: 255'	Structural integrity intact. No action needed.	
8	5100	1852-0009	1852-0008	STARDUST RD	Hole at base of MH 8	CSMD will repair base of MH 8.
